Ground Subsidence in the City of Tuzla (Bosnia & Herzegovina)

Bojana Grujić¹, Žarko Grujić¹

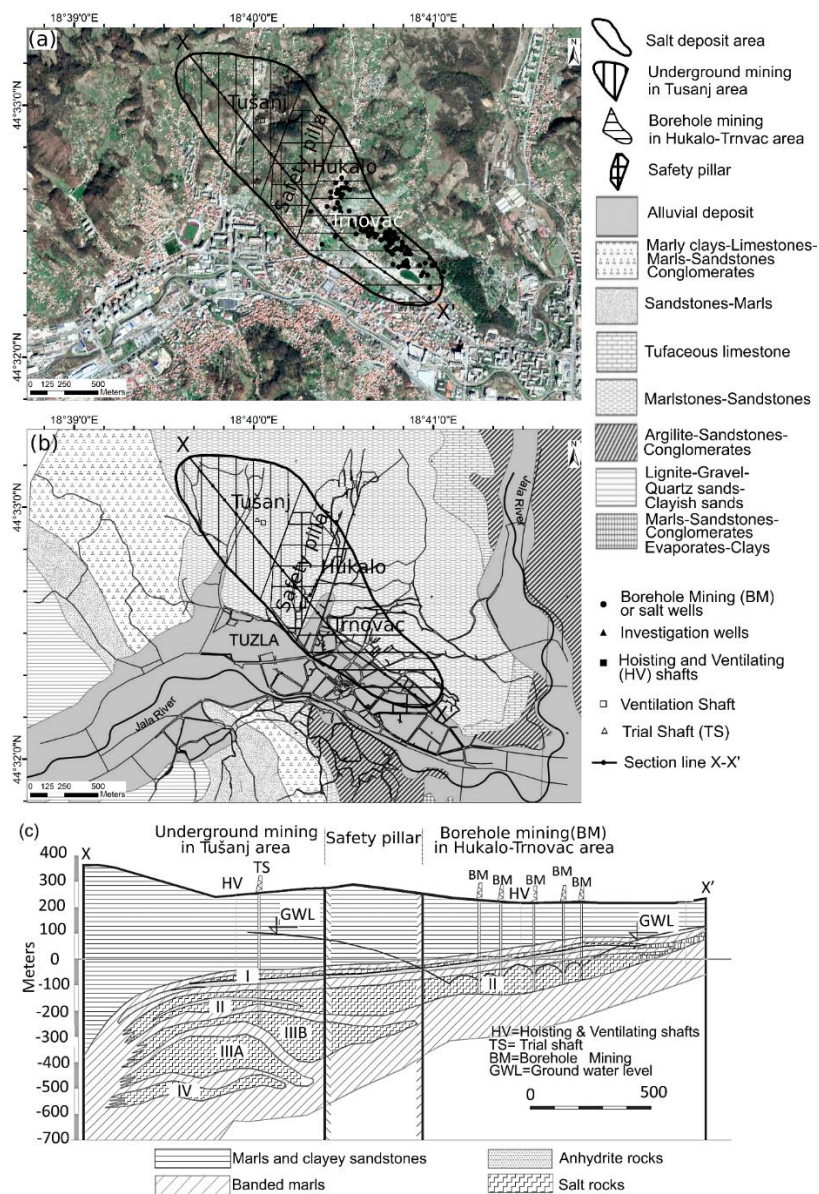
Figure 1. Geological conditions of Tuzla: (a) plan view using background aerial photo from Google Earth Pro and location of salt wells, (b) plan view (modified from Mancini et al., 2009), and (c) vertical X-X' cross section

The Tuzla salt deposit is located under an urban area and extends over 2 km² (Figure 1(a)). The horizontal projection of the deposit has the shape of an ellipse, with a length of about 2500 m and a width of about 900 m. The geological features have been investigated by several authors (Cicic, 2002; Hrvatović, 2006; Jovanović, 1980; Katzer, 1903; Redžepović et al., 2006; Soklić, 1959, 1964; Stevanović, 1977; Tari and Pamić, 1998; Vrabac, 1999). The deposit consists of five separated salt series, or stratigraphic layers, which contain salt rocks embedded in a syncline with one of the limbs close to the surface of the city's center (Figures 1(b) and 1(c)). The maximum thickness of the salt formation is about 600 meters. It is composed of marls and clayey sandstones, salt rocks, banded marls, and anhydrite rocks, as shown by the vertical cross section of X-X' in Figure 1(c).

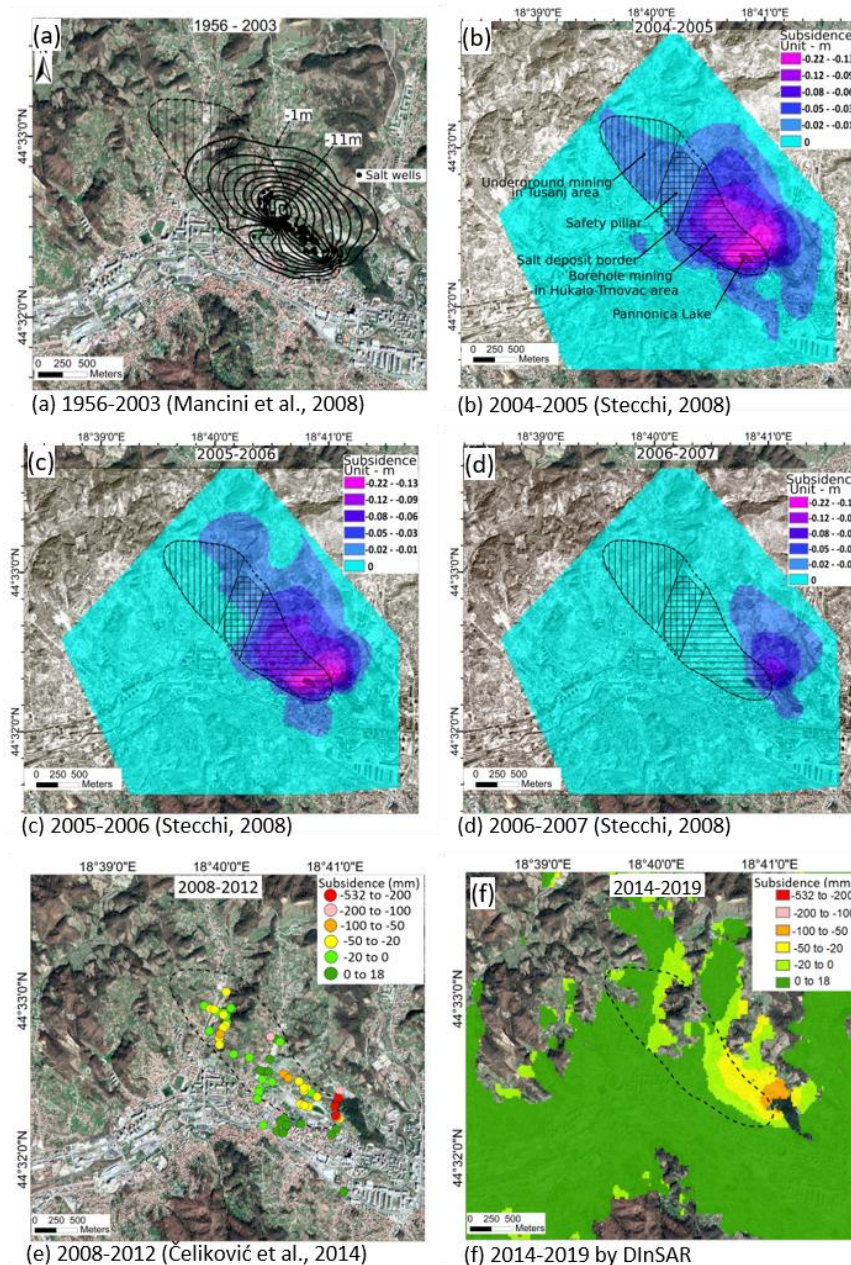
Figure 2. Time transition of spatial distribution of subsidence in Tuzla from 1956: (a) cumulative subsidence obtained by traditional topographic surveys from 1956-2003 presented by contour lines (dashed line indicates salt deposit border added by the authors), (b) subsidence in Tuzla obtained by GPS surveys from 2004 – 2005, (c) subsidence in Tuzla obtained by GPS surveys from 2005 – 2006, and (d) subsidence from 2006 to 2007 (modified from Stecchi (2008)), (e) Subsidence from 2008 to 2012 obtained by GNSS and geodetic methods (Čeliković et al. 2014), and (f) Subsidence from 2014 to 2019 obtained by SBAS-DInSAR. (salt deposit border, safety pillar, and mining region were added by the authors).

Figure 2(a) shows the contour lines for the subsidence from 1956-2003 presented by Mancini et al. (2009). The figure reveals that the maximum subsidence reached -12 m. It was found that the large subsidence extended to the north of the city, including a residential area, and was shaped like a trough. Figures 2(b), (c), and (d) show the subsidence distributions measured at four different times by static GPS surveys, namely, in 2004, 2005, 2006, and 2007 (Mancini et al., 2009; Stecchi, 2008). The survey network was composed of six reference points and 60 densification measurement points (Mancini et al., 2009).

The GPS results for 2004-2005 show that the subsidence continued at a rate of -12 ~ -22 cm/year in the north part of Pannonica Lakes (Figure 2(b)), although the rate had largely decreased compared to that of the previous period (1956-2003). A considerable area of the northeast part of the city was subjected to subsidence rates of -2 ~ -5 cm/year. In the period of 2005-2006, the subsidence rate decreased to -8 ~ -22 cm/year around Pannonica Lakes (Figure 2(c)). Mancini et al. (2009) and Stecchi (2008) stated that the GPS results from 2006-2007 showed that the subsidence was heading to the end almost everywhere, except for the area near Pannonica Lakes where the subsidence rate was still about -10 cm/year (Mancini et al., 2009; Stecchi, 2008) (Figure 2(d)).

Figure 2(e) shows the spatial distribution of the subsidence measured by GNSS and geodetic surveys from 2008-2012. The distribution of subsidence is similar to that by GNSS from 2004-2007. Large subsidence was found around the most eastern part of the salt deposit. The subsidence became small toward the northwest parts of the salt deposit. The maximum subsidence of -53.2 cm was found at a point in a hilly area located in the southeast part of the salt deposit.

Figure 2(f) shows the spatial distribution of the subsidence obtained by SBAS-DInSAR for the period of October 2014 to May 2019. This spatial distribution is similar to those by GNSS surveys from 2004-2007 and by GNSS and geodetic surveys from 2008-2012. It means that the subsidence still continued in a similar manner even after the extraction of salt water had been terminated in 2007. However, the absolute value of the subsidence has been decreasing. It is also important to reveal the mechanism of the present subsidence behavior.

From Figures 2(a)-(f), the location of the large subsidence area is seen to have moved to the southeast border of the salt mine deposit (northeast from Pannonica Lakes), while it was located in the center of the salt mine region in the previous period (1956-2003). It should be noted that the complex hydrodynamic groundwater system for the city of Tuzla plays a major role in the creation and speed of the settlement. In the northeast hilly area of Pannonica Lakes, large horizontal displacements were detected (Čeliković et al., 2014; Čeliković & Imamović, 2016) and the complex behavior comprising a combination of landslides and subsidence has appeared.

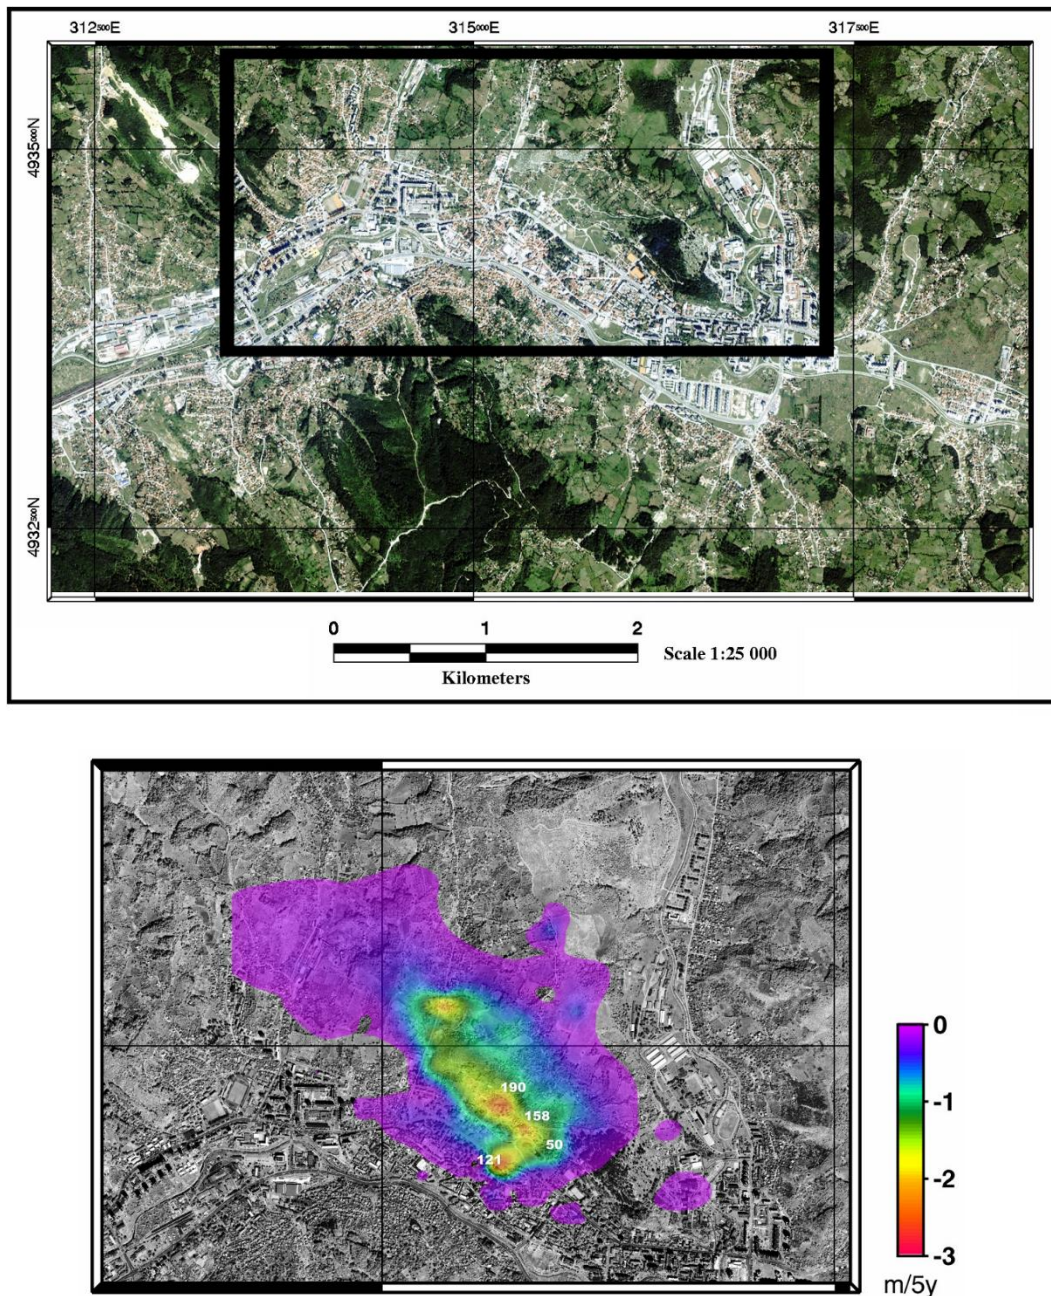
Figure 3. Tuzla observed by using multispectral data (above) and a portion (below) by panchromatic data. Colours represent the subsidence rates between 1981 and 1986.

of maps, showing the subsidence rates over the last half century, is fundamental for the delimitation of the most sinking area along with the evaluation of time varying phenomenon and its relation with wells activity. Figure 3 shows a portion of the Tuzla urbanized area (above) as 321 RGB multispectral data and a detail (below) of collapsing phenomena occurred from the year 1981 to the year 1986 superimposed to 1-meter panchromatic data. As can be seen from Figure 3 over the 5 years the sinking reaches the considerable rates of 3 meters with a risk area showing a typical ellipsoidal shape corresponding to the most intensively exploitation area. The contouring of rates processed in the period spanning from the year 1955 to the year 1990 shows a very similar sinking rates with a decreasing trend until the year 1990, as a consequence of the reduced salt extraction by the wells. In addition it should be pointed out that a certain number of benchmarks were destroyed by the deformation itself. In the most damaged zone, a green and recreational area was created after the demolition of damaged buildings. As obvious, in that part of the city data were not collected anymore.
